GROUNDWATER
SERVICES, INC.

**WORKPLAN FOR SITE ASSESSMENT OF
PORTIONS OF A, B, AND C YARDS**

Southwest Shipyard
Channelview, Texas

GSI Job No. G-2076
Revision No. 0
Issued: 10/27/97

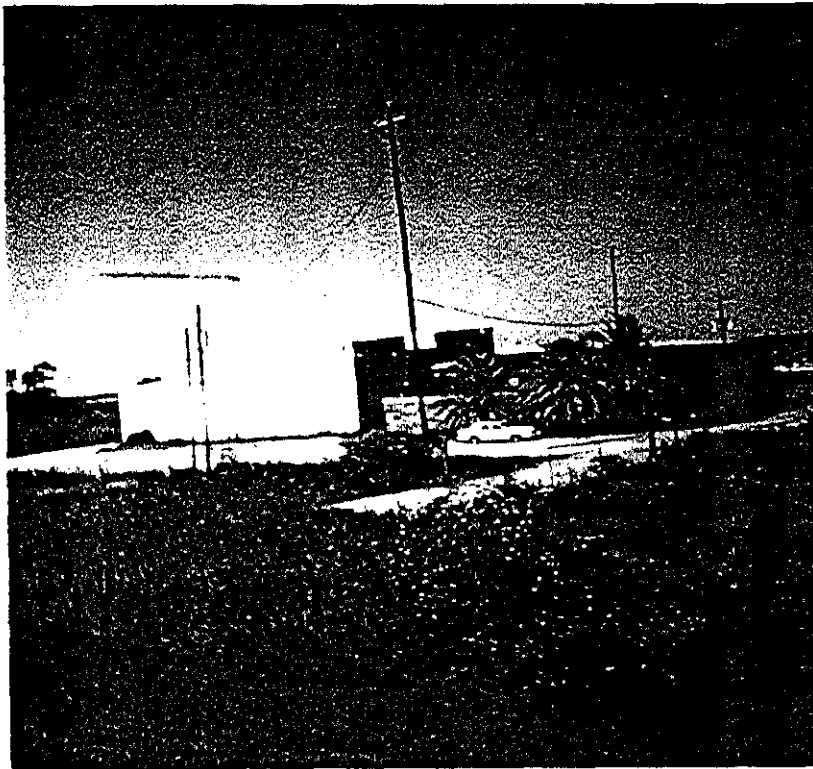
GSI Job No:	G-2076	Drawn By:	DLB
Issued:	10/27/97	Chk'd By:	EAH
Revised:	—	Appv'd By:	EAH
Scale:	As Shown	FIGURE 7

**Current Dredging Operations at
Former Barge Painting Area on C Yard**
(photograph taken facing north on 10/14/97)
